Manhole Inspection Summary

Manhole # S01YY1014MH

Insp Date: **10/12/06 8:45 AM**

Location Address: **3401 Taney Rd**

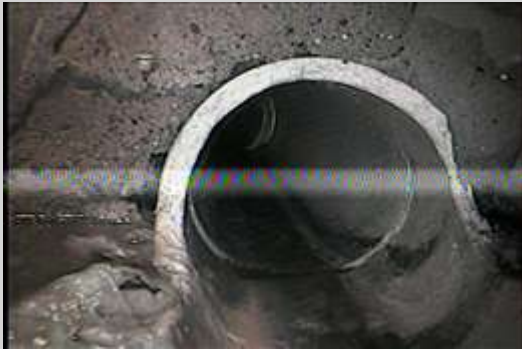
8 in. Circular Gravity Sewer Pipe Out @ 12 O'Clock

Pipe Material: **Clay** ☐ Pipe Lined

Invert Depth: **6.54** (ft.) Flow Characteristics: **Slow**

Deposits: ☐ None ☐ Mud ☐ Sludge ☒ **Debris** ☐ Grease

Silt Depth: **0.125** (in.) Deposits Extent: **Light**

Infiltration: **None** Pipe Seal Cond: **Sound**

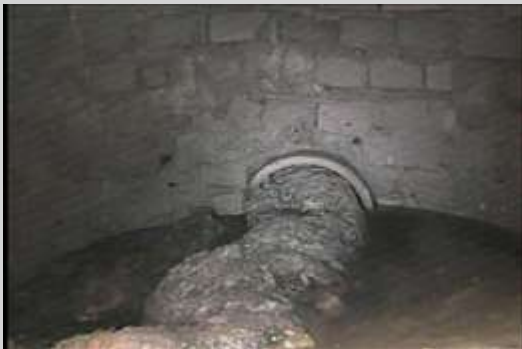
8 in. Circular Gravity Sewer Pipe In @ 3 O'Clock

Pipe Material: **Clay** ☐ Pipe Lined

Invert Depth: **6.40** (ft.) Flow Characteristics: **None**

Deposits: ☐ None ☐ Mud ☐ Sludge ☒ **Debris** ☐ Grease

Silt Depth: **6** (in.) Deposits Extent: **Heavy**

Infiltration: **None** Pipe Seal Cond: **Sound**

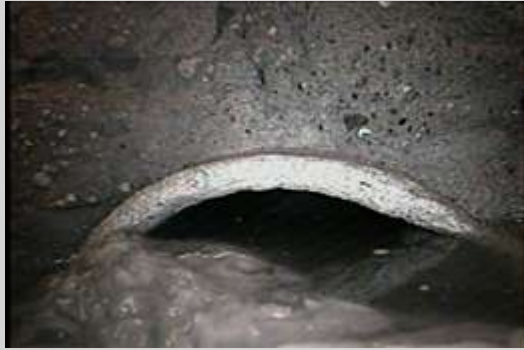
8 in. Circular Gravity Sewer

Pipe Material: **Clay**

Invert Depth: **6.50** (ft.) Flow Characteristics: **Slow**

Deposits: ☐ None ☐ Mud ☐ Sludge ☒ **Debris** ☐ Grease

Silt Depth: **4** (in.)

Deposits Extent: **Heavy**

Infiltration: **None**

Pipe Seal Cond: **Sound**
